# National Transportation Safety Board

DCA22WA102

## **COCKPIT VOICE AND FLIGHT DATA RECORDER**

Location: Wuzhou, China  
Date: March 21, 2022  
Time: 0630 UTC  
Airplane: Boeing 737-800, China Eastern Airlines, Registration B-1791

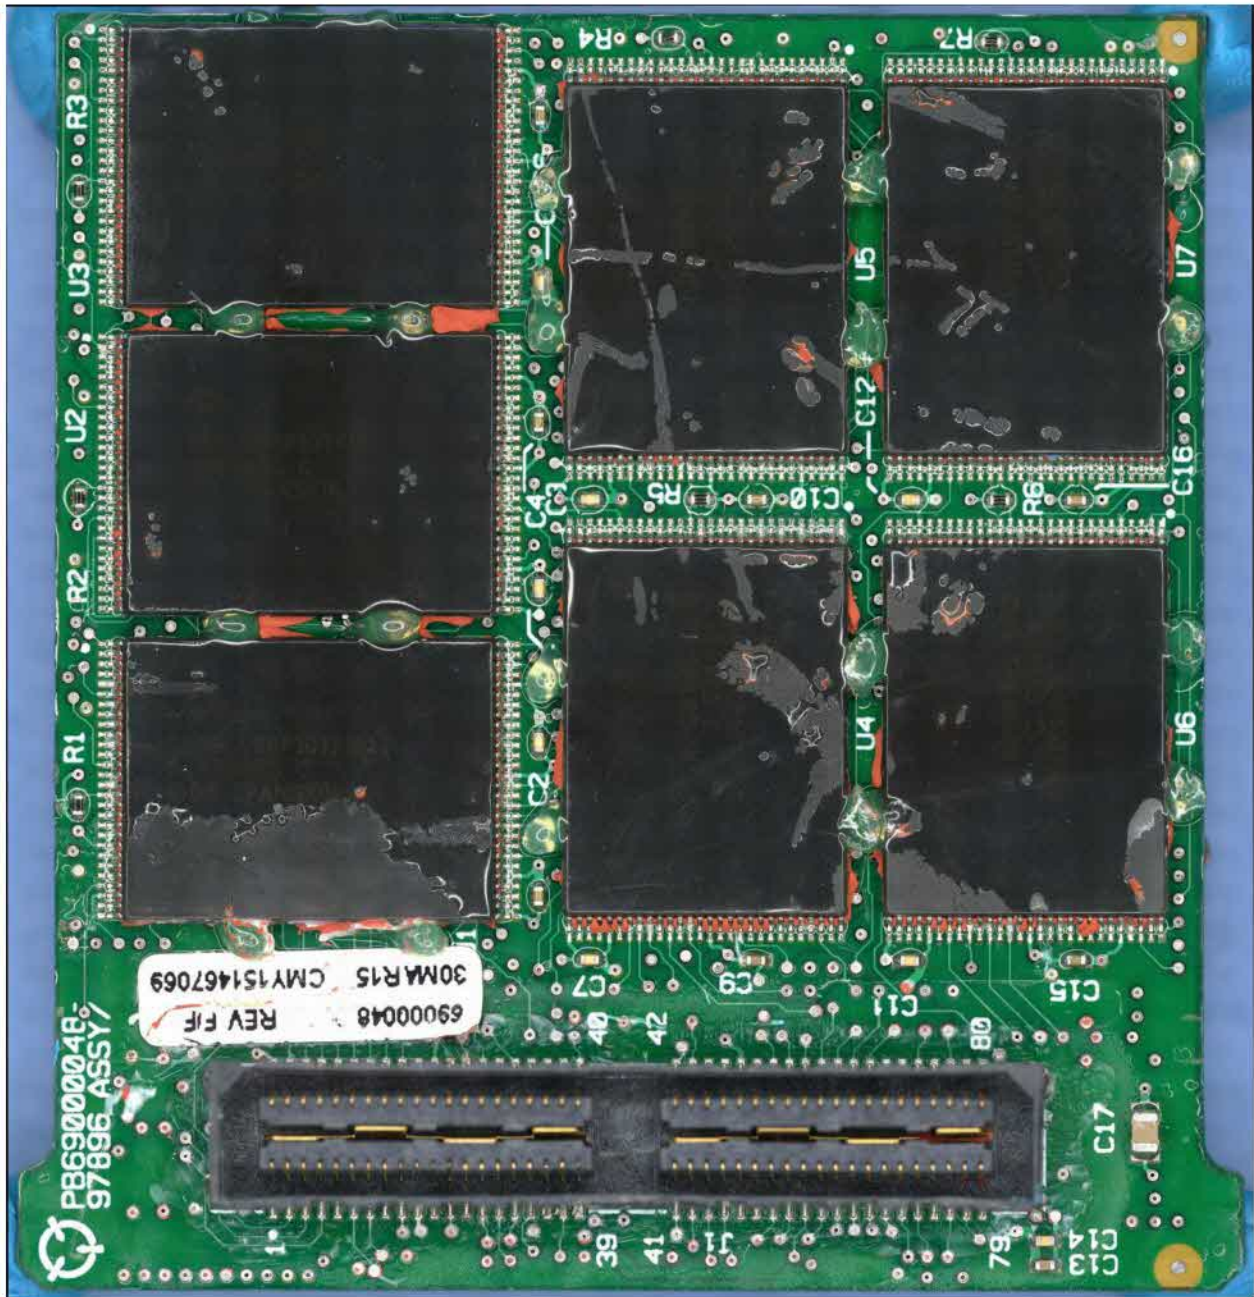
The CVR memory module was presented to the NTSB for microscopic inspection. Figure 1 shows the connector side of the board and Figure 2 shows the opposite side. Both sides have FLASH memory chips containing data. Preliminary findings showed the board to have substantial damage to the connector area of the device. Numerous solder pads attaching the connector to the board and providing the electrical signal path to the data chips were found bent or completely dislodged from the board. (See Attachment 1, CMM Recovery Report, for additional details and specifics of connector damage). The damaged pins corresponded to chip data lines and address lines. This damage would be significant to the download and is consistent with the audio artifacts present in the data. Damage to chip data lines would manifest as quantization error-type digital noise and damage to chip address lines would manifest as stuttering, echoing, and repeating-type noises.

Figure 1. CVR memory module board, connector side.

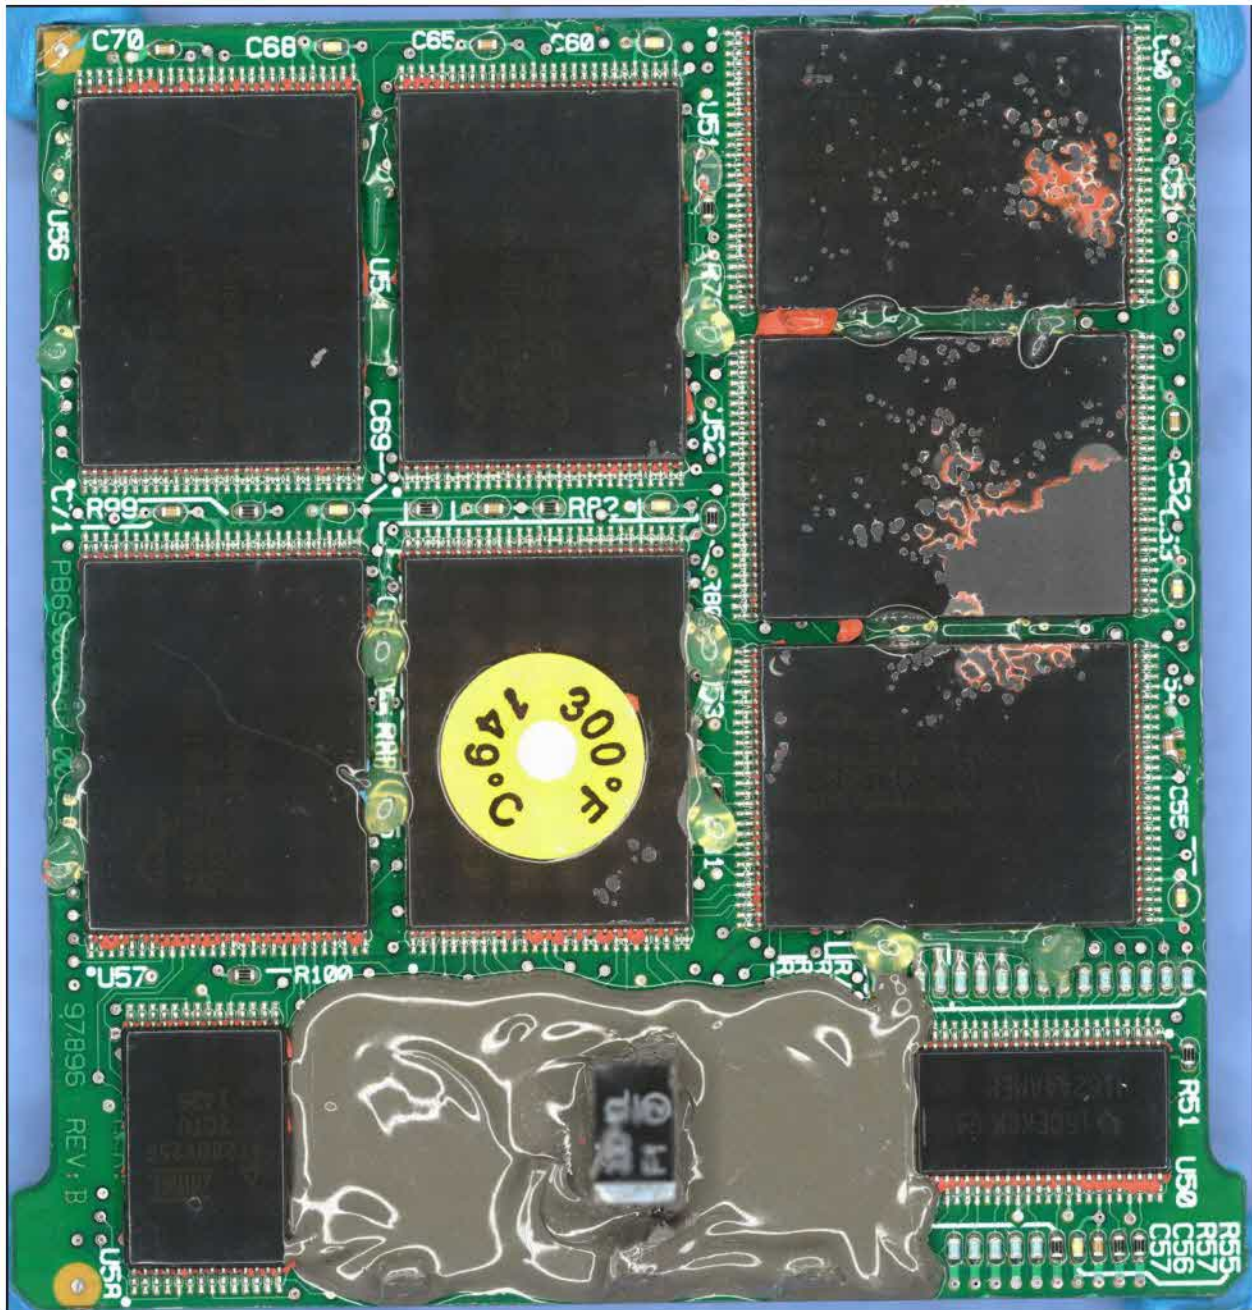
**Figure 2. CVR memory board, side opposite connector.**

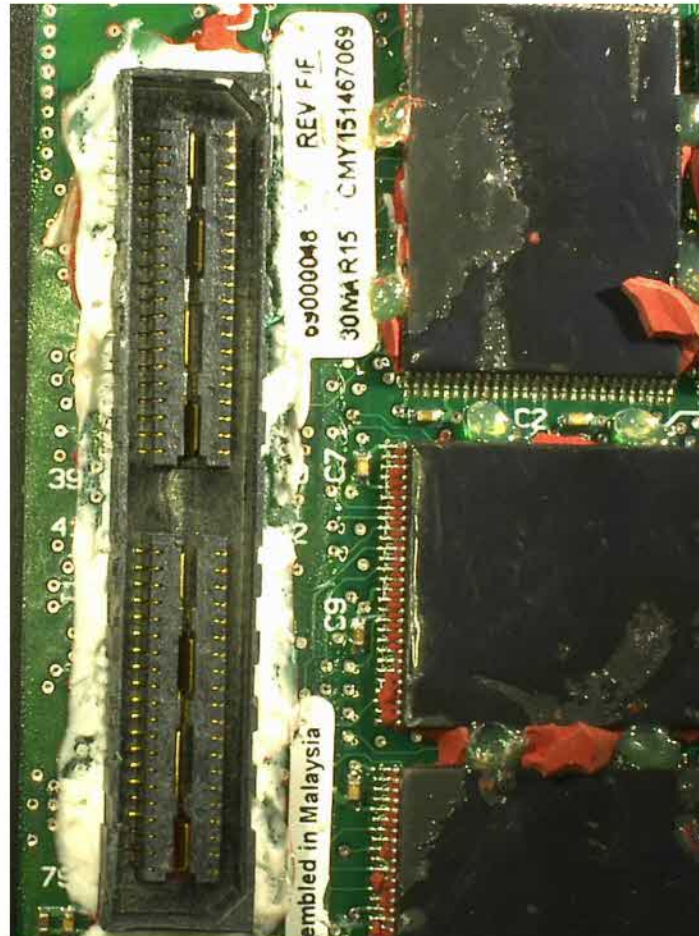
Further inspections also revealed that the plastic portion of the connector itself was deformed subtly out of its normal state. The long edge along the board end was

raised above its normal position, and the pins along that edge were recessed inside the connector housing. In this state it would have been difficult for the male pins on the recovery cable to make a reliable connection with the board. The long edge facing the memory chips was crushed down below its normal position with the pins projecting out notably from the connector housing. It was also found that the ground plane between the two sides of the connector was damaged underneath the connector housing. Several sections of the ground plane were severed or lifted from the board. Figure 3 shows the connector, as received.

**Figure 3. Detail of CVR memory module connector, as received.**

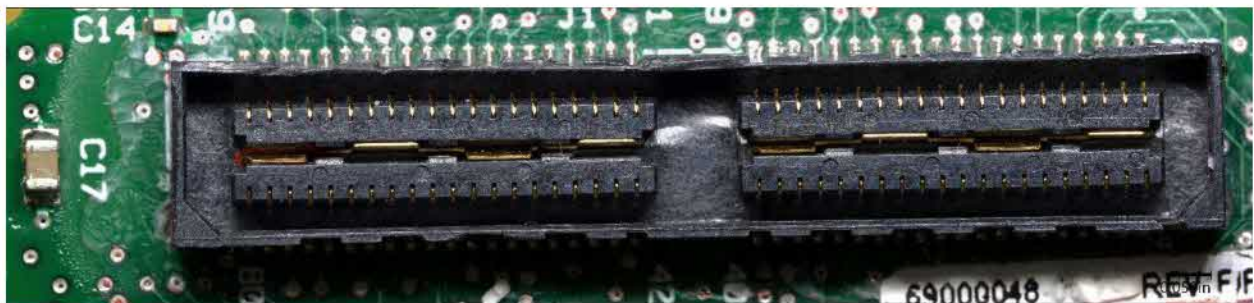
To finalize the preliminary inspections of the board, the remaining RTV sealant on the board was carefully removed from the connector area. All the pins from the connector that were accessible for inspection were physically tested for integrity. (Some pins were not accessible because they were routed under the board.) Numerous loose or separated pins were catalogued. Figure 4 shows the connector prepped for inspection with remaining RTV sealant removed.

**Figure 4. Connector detail with RTV sealant removed.**

The loose and separated pins found in the inspections were repaired using a microscope and a special cyanoacrylate glue. To help make the best connection possible with the damaged board connector, an HFR-5 recovery flex cable was modified to aid in positive connections between the cable and the board. Many of the pins on the cable were bent slightly away from the plastic of the connector, causing them to interface better with the pins that were recessed into the damaged board connector.

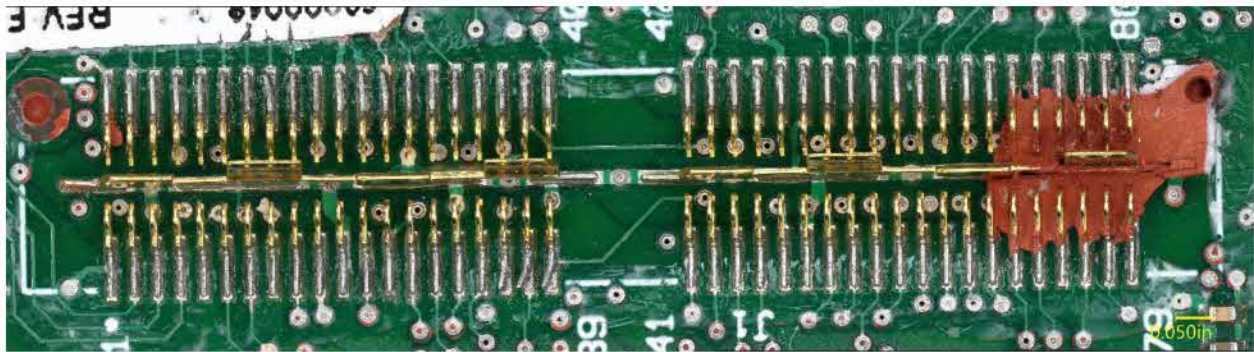
The CVR connector housing was fully removed, which revealed additional damage to the pins that was hidden underneath the plastic. Pins were found pushed down underneath the plastic and numerous additional pads and traces were found to be loose or completely removed from the board. It is likely that the only reason some pins were making contact was that they were pinned down to the board by the connector housing itself. The central ground planes were found to be loose at every attachment point except for one. The memory module with the connector shell removed is shown in Figure 5. Some of the deformations to the pins is shown in Figure 6.

**Figure 5. Detail view of connector pins with shell removed.**

The pins, now without the plastic connector shell, were again stabilized and loose areas were reworked with cyanoacrylate glue and allowed to cure. With the pins completely stabilized work was undertaken to carefully re-shape them into their proper positions. The pins on the surrogate board were used as a template for this activity. Re-shaping the pins into the best approximation of their original shapes provided the best chance of securely mating to the recovery cable once the plastic housing was replaced. With the pins re-shaped it also became clear that the odd-numbered pins were critically close to many of the uninsulated vias and traces, which was previously hidden by the connector shell. To solve this issue a thin insulation strip was fabricated out of Kapton tape and placed between the pins and the board.

A new connector shell was carefully installed over the reworked pins. This work was performed under the microscope due to the delicate nature of the pins and the need to have them align with the individual grooves in the connector. The modified flex cable was mated to the board and secured with ESD tape. The board and flex cable assembly was then attached to the NTSB HFR5-V golden chassis and downloaded using both Playback32 and DLDR.

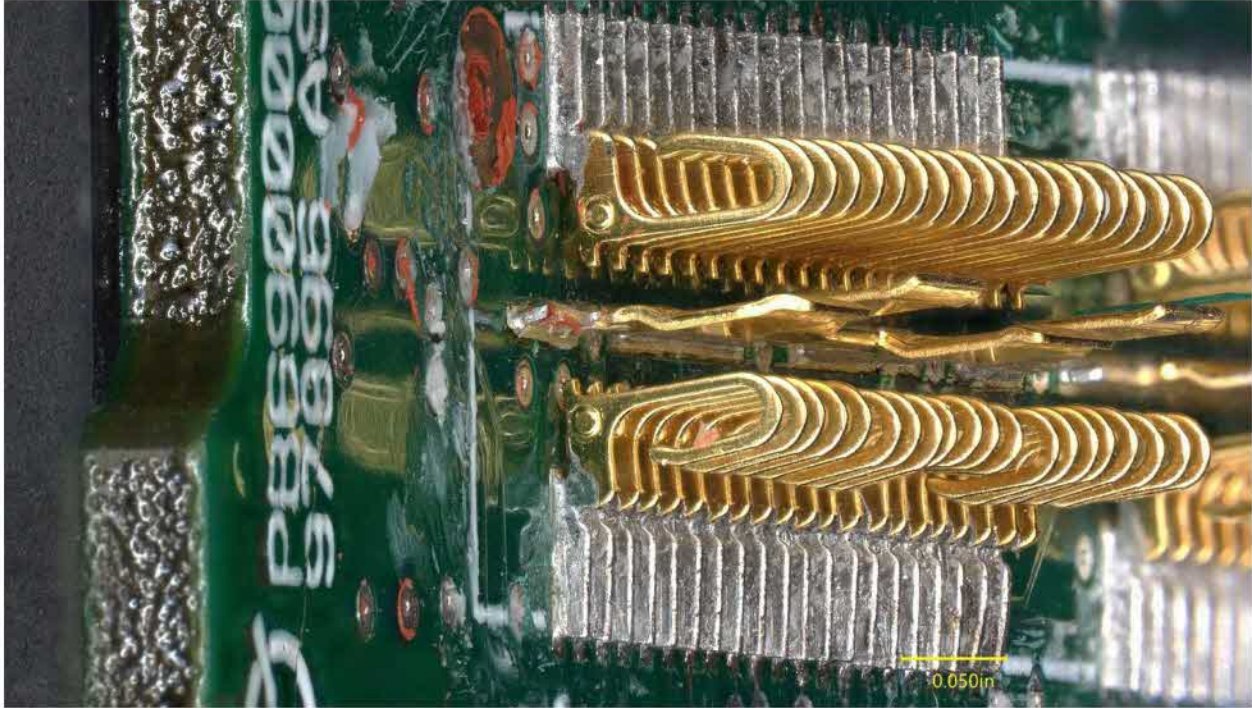
**Figure 6. Detailed view of deformed pins.**

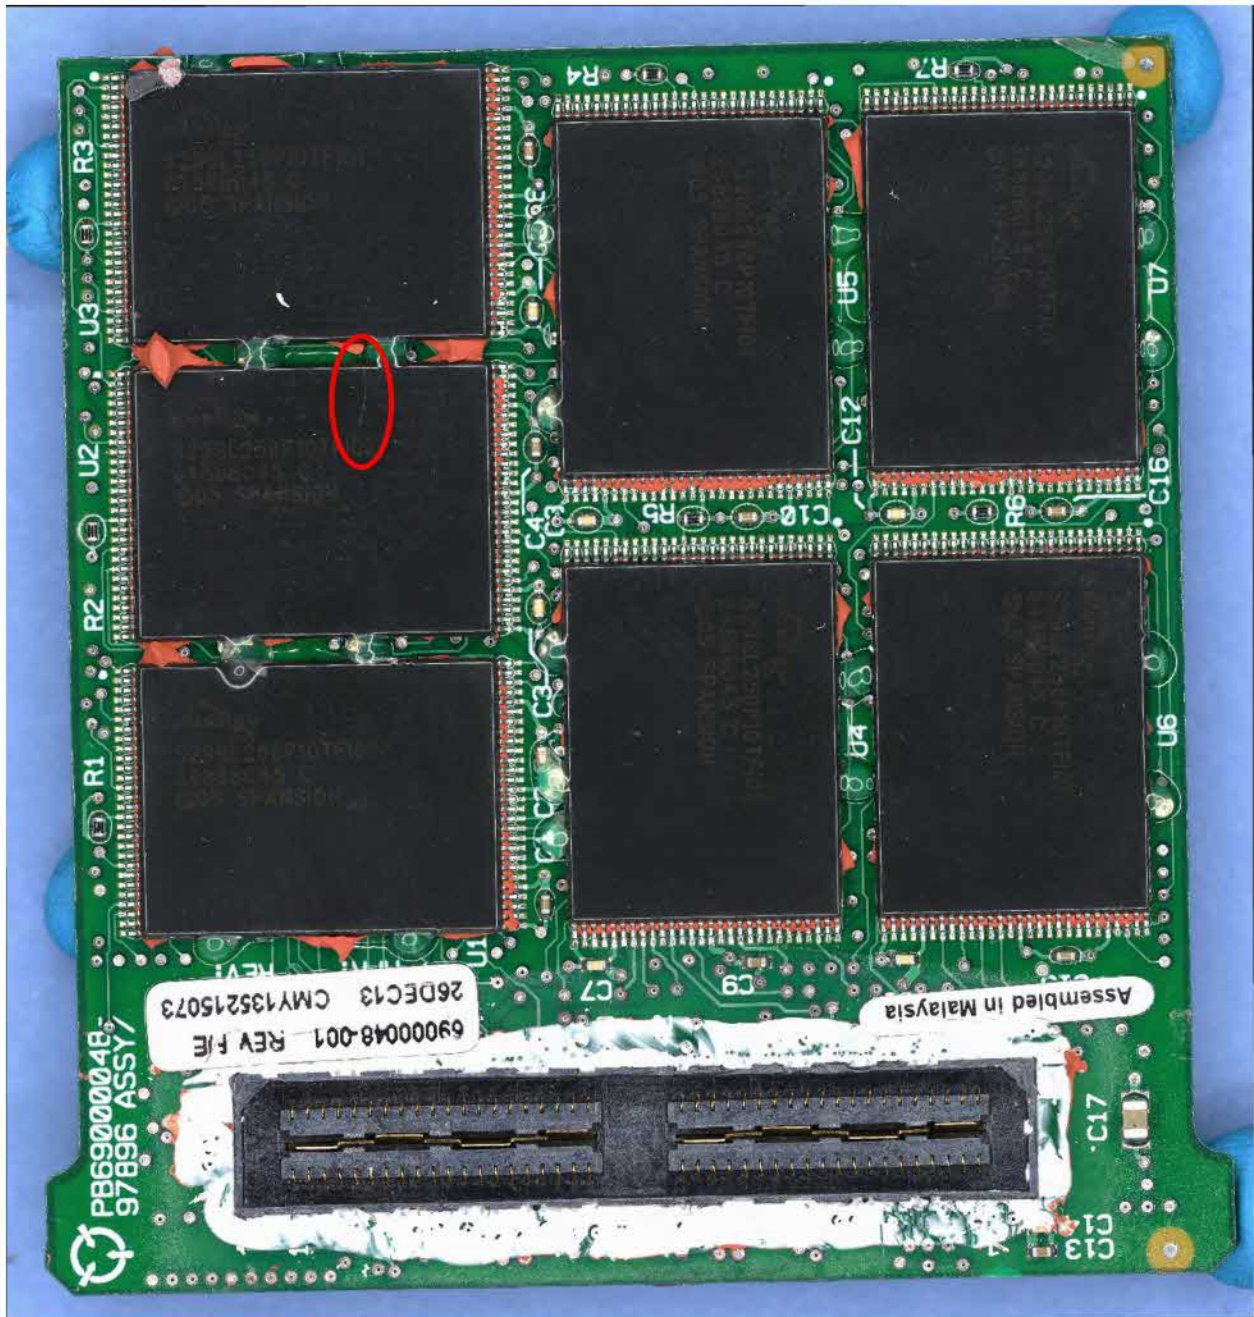
The red RTV was removed from the FDR memory board to allow for an initial visual inspection of the entire module. Figures 7 and 8 show the connector side and opposite side, respectively, of the FDR memory module. The module was inspected under high-power microscopy, revealing that FLASH module number U2 had a crack extending from the top edge of the memory packaging into the center of the chip. The crack penetrated to the surface of the conformal coating over the device. Many of the epoxy balls bonding the chip to the board also showed evidence of cracking and/or separation from the FLASH devices to which they were originally adhered.

**Figure 7. Connector side of FDR memory module with crack faintly visible in chip U2, marked with a red circle in the photograph.**

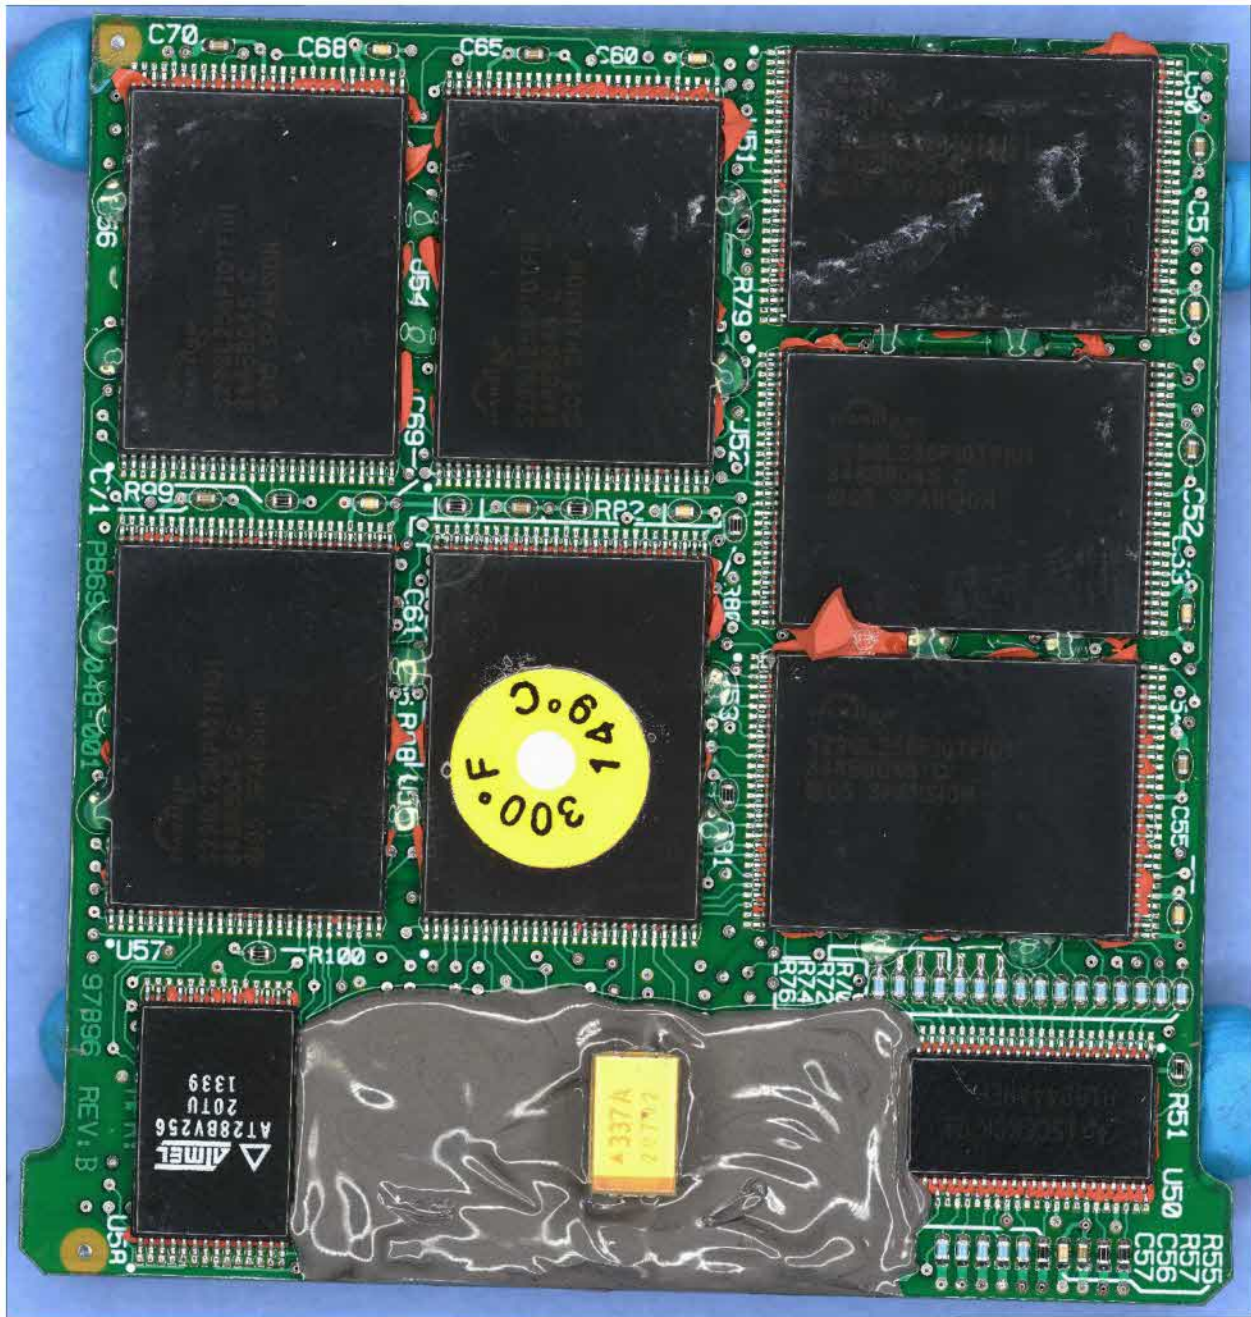
**Figure 8. FDR memory module side opposite connector.**

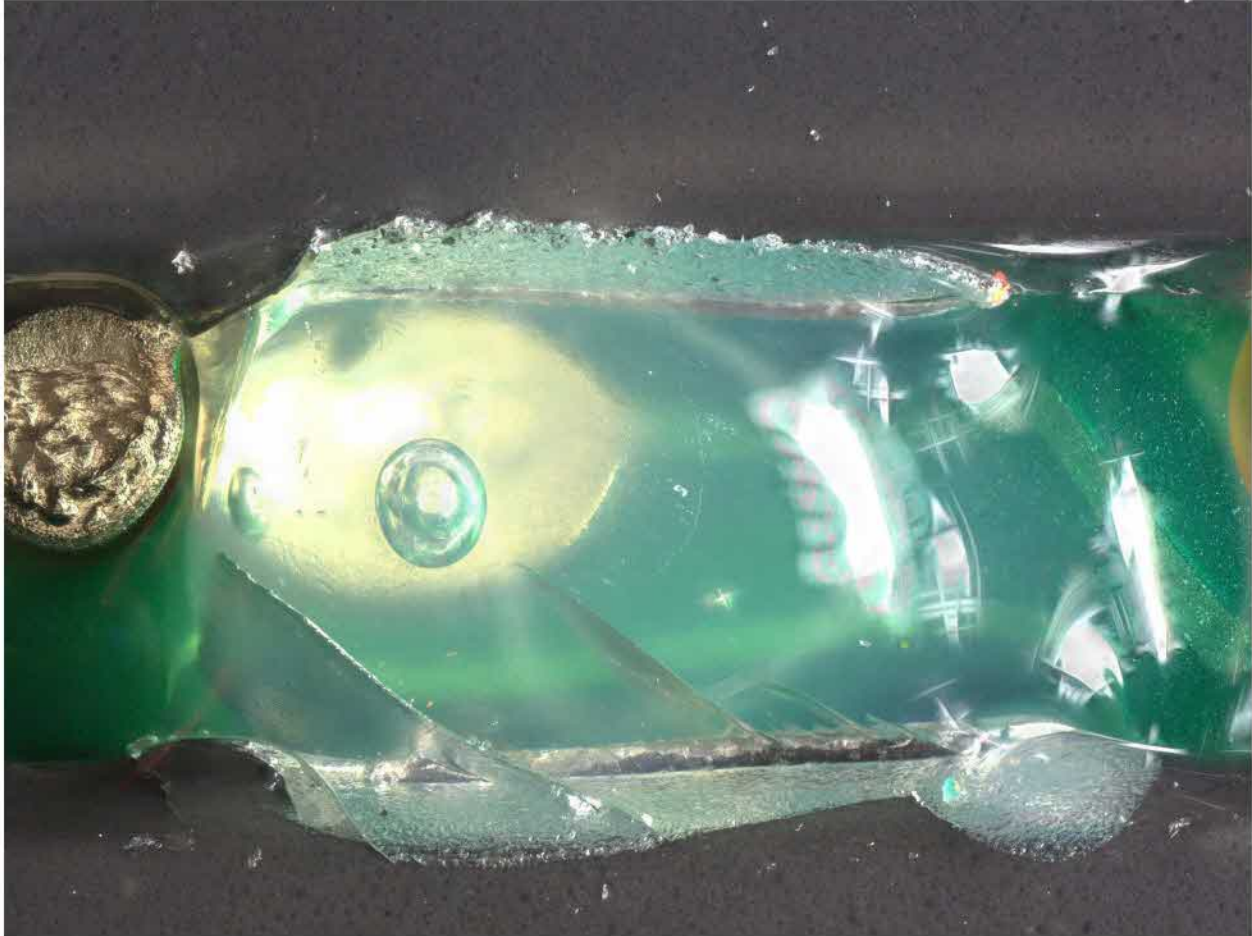
Additional minor cracking was found in the chip packaging areas of many of the epoxy bonds between FLASH modules. This included minor cracking in FLASH module numbers U1 & U2, U5 & U7, and U51 & U52. The majority of the epoxy bonds on both sides of the memory module showed evidence of fractures. Figure 9 shows an example of the cracking seen in the epoxy bond between chips U1 and U2.

**Figure 9. Example of cracks seen in epoxy bond between chips U1 and U2.**

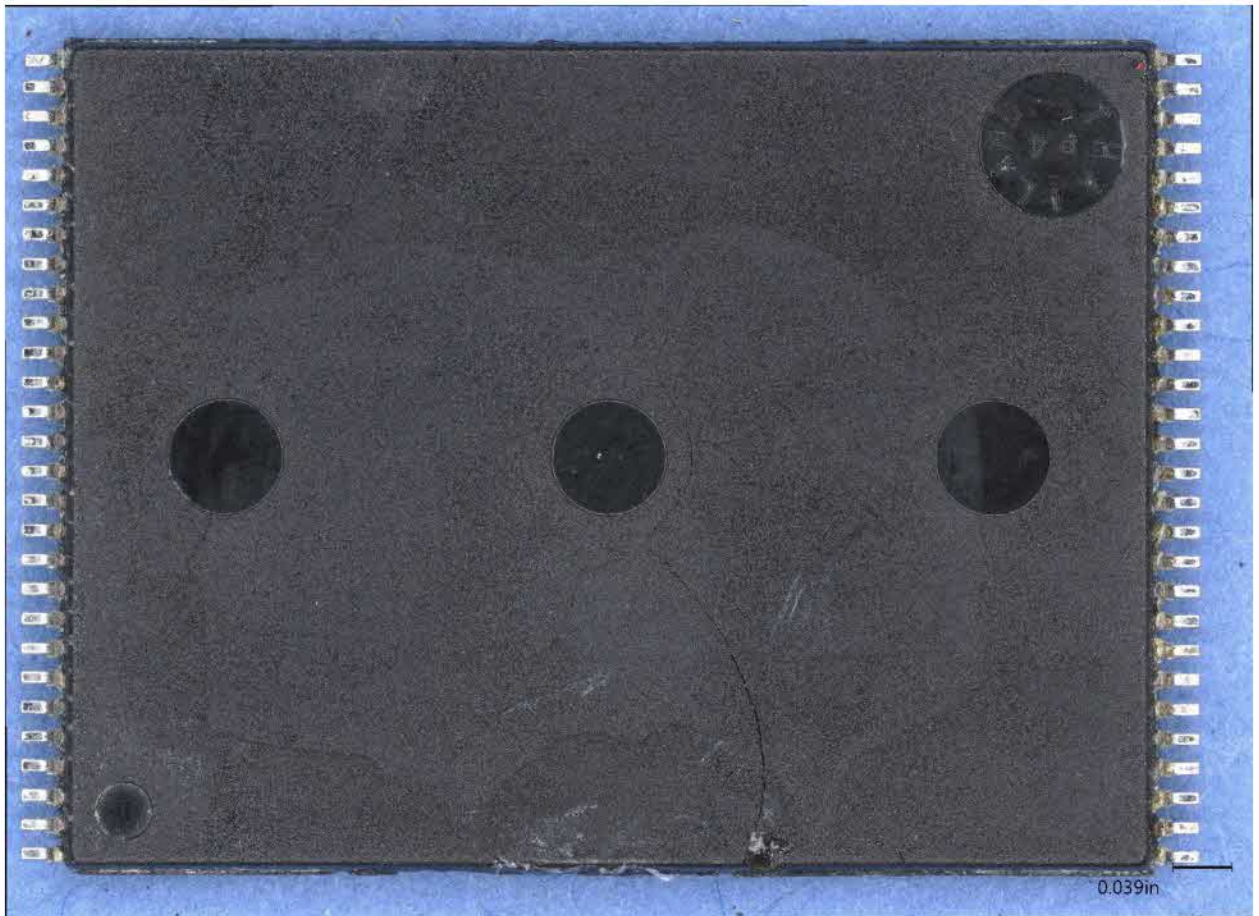
An inspection of chip U2 (the chip with the visible crack in the packaging) identified a network of cracks on the bottom of the chip in addition to the previously observed crack. The other chips did not reveal additional damage when they were removed from the board. Figure 10 shows the bottom of chip U2 following removal from the board.

**Figure 10. Bottom side of chip U2 showing cracks throughout chip packaging.**

The chips were read in the Xeltec memory reader and the resulting binary images for chips U1, U3, U4, U5, and U6 were found to contain data. Chip U2 could not be read and the Xeltec reported numerous pin-check errors and messages indicating that many of the pins were shorted. This was a sign of significant internal damage to the silicon die within the chip itself.

Chip U2 was X-rayed and CT scanned, and chip U4 was also X-rayed as an exemplar. The results of the CT scan were noisy and revealed no new information. Some of the cracks identified visually on the bottom side of the packaging were apparent in the 2-D X-ray images. These cracks passed through the region of the chip housing the silicon die containing all the internal circuitry. Several other of the undersurface cracks were not visible in the X-ray because they appeared to follow the outline of the X-shaped copper die pad upon which the silicon die was bonded during manufacture of the chip. This extreme damage rendered any data from U2 unrecoverable.

A dummy file of all hexadecimal 'FF' (binary '1') was created and used in place of the image from U2 in the Honeywell CHIPS utility to create a FDR DLU file. The resultant DLU file was then imported into the NTSB CIDER data analysis application. The data was framed out with information provided by the aircraft manufacturer.

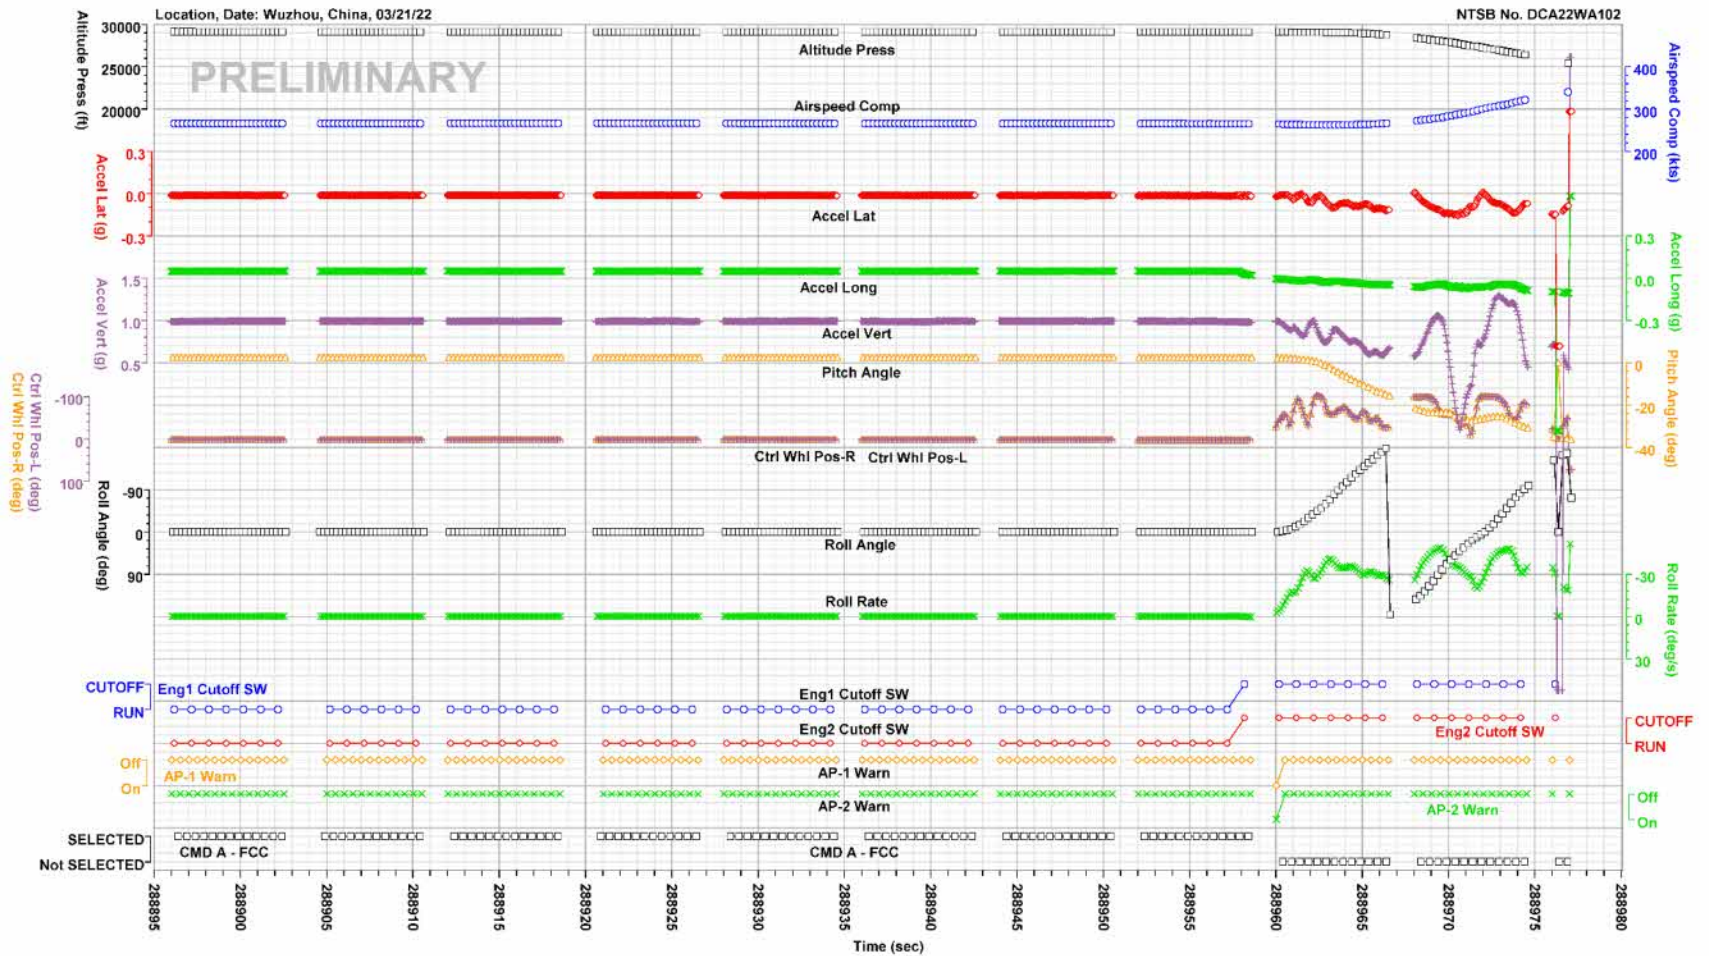
**Figure 11. Basic aircraft parameters from final 90 seconds of recording.**

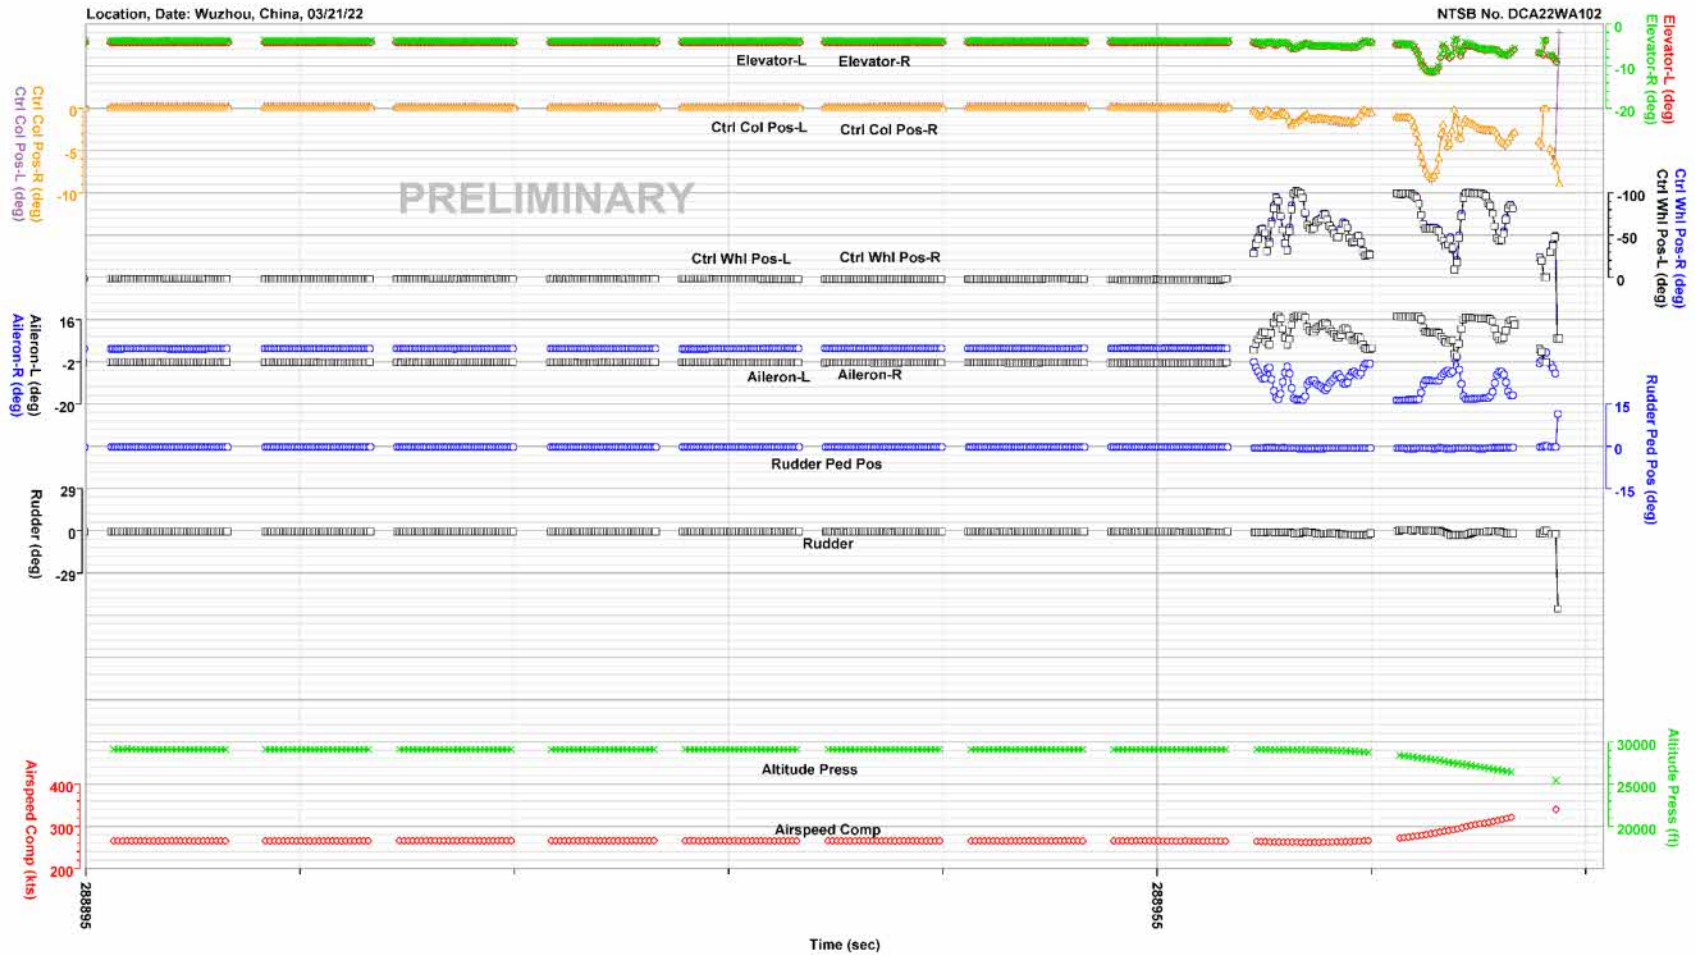
Figure 12. Flight control and input positions for final 90 seconds of recording.
