# National Transportation Safety Board

DCA22WA102

## **COCKPIT VOICE AND FLIGHT DATA RECORDER**

Location: Wuzhou, China  
Date: March 21, 2022  
Time: 0630 UTC  
Airplane: Boeing 737-800, China Eastern Airlines, Registration B-1791

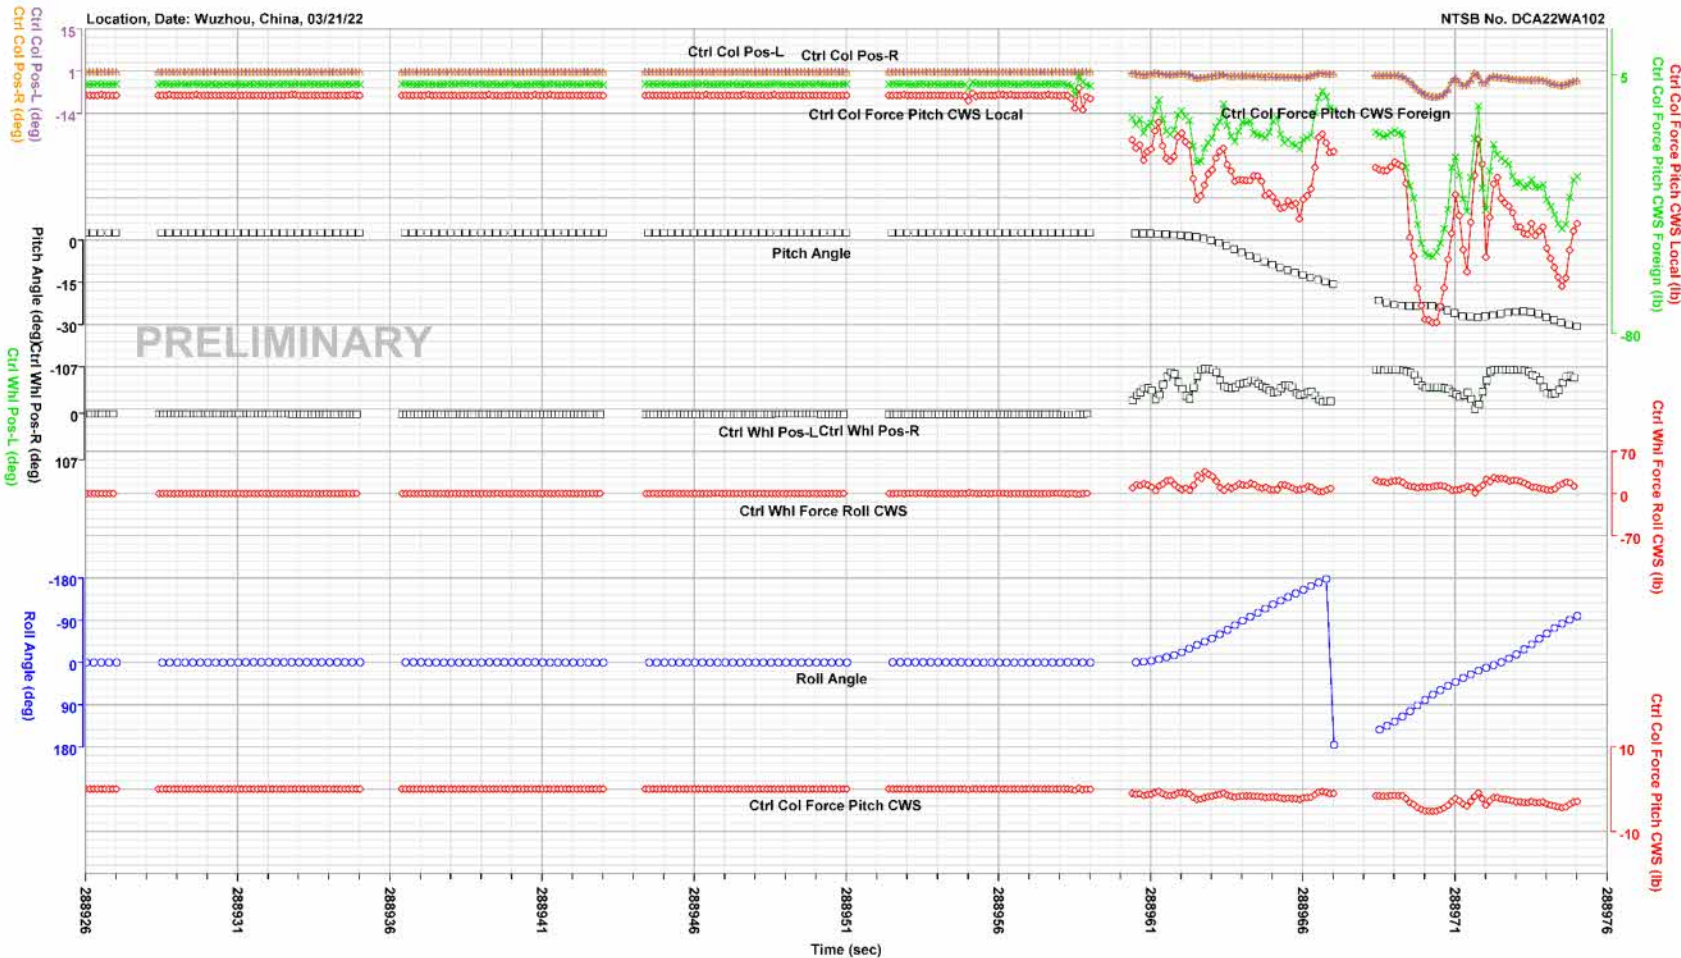
Figure 12. Flight control and input positions for final 90 seconds of recording.

The FDR data ended with the aircraft still in flight. The data stopped with the aircraft in a descent at approximately 26,000 ft. It did not capture the remainder of the descent and final accident sequence. Investigating the reason for the premature end of the flight data it was found that while at cruise at 29,000 ft, both engine N2 values decreased rapidly below the point at which the generators drop offline. The FDR does not have a battery backup, so without power from the aircraft generators it will power down. This is different from the CVR, which does have a battery backup and can continue recording for at least 10 minutes after the loss of the aircraft generators. Looking for the reason that the engine N2 dropped below the generator cutoff speed, it was found that while cruising at 29,000 ft, the fuel switches on both engines moved from the run position to the cutoff position. Engine speeds decreased after the fuel switch movement.
